# Manhole Inspection Summary

Manhole # S21I\_\_006MH

Insp Date: **9/20/07 2:03 PM**

**Location** Address: **1829 BOOTH ST**

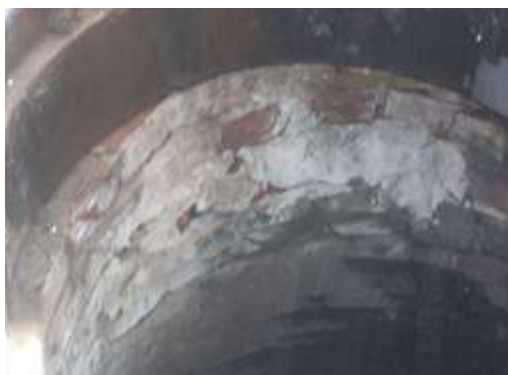
Defect 3

Condition: ☐ Sound ☐ Cracked ☐ Root Intrusion ☒ **Loose Brick** ☐ Deteriorated

LOOSE CORBEL BRICKS

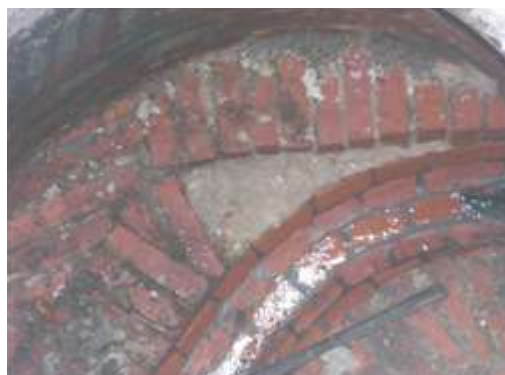
Defect 2

Condition: ☐ Sound ☐ Cracked ☐ Root Intrusion ☒ **Deteriorated** ☐ Leaks ☐ Debris

DETERIORATED BENCH

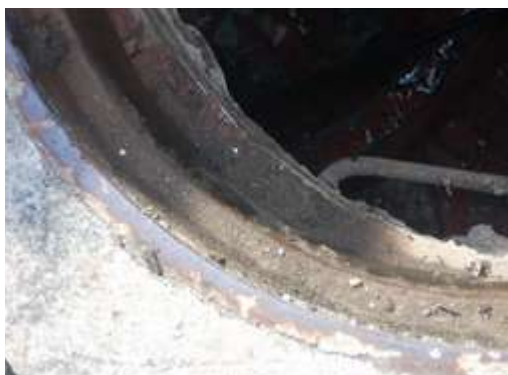
Defect 1

**Frame** Offset: **2** (in.) Condition: ☒ Sound ☐ Cracked ☐ Leaks

FRAME OFFSET

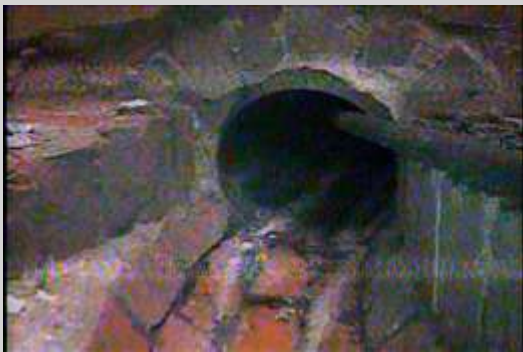
12 O'Clock Outflow

8 in. Circular Gravity Sewer  
Pipe Out @ 12 O'Clock

Pipe Height: **7.2** (in.) Rod and Bar (Angled)  
Pipe Material: **Clay** ☐ Pipe Lined  
Invert Depth: **7.30** (ft.) Flow Characteristics: **Slow**  
Deposits: ☒ None ☐ Mud ☐ Sludge ☐ Debris ☐ Grease  
Silt Depth: (in.) Deposits Extent:  
Infiltration: **None** Pipe Seal Cond: **Sound**

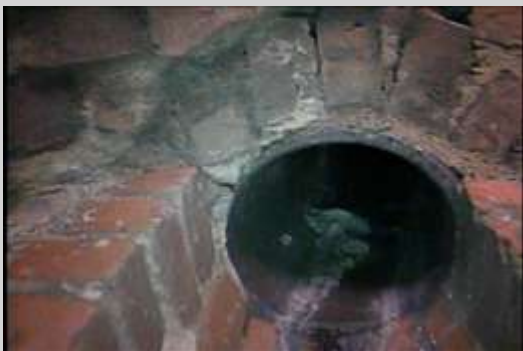
6 O'Clock Inflow

8 in. Circular Gravity Sewer  
Pipe In @ 6 O'Clock

Pipe Height: **8.4** (in.) Rod and Bar (Angled)  
Pipe Material: **Clay** ☐ Pipe Lined  
Invert Depth: **6.86** (ft.) Flow Characteristics: **Slow**  
Deposits: ☒ None ☐ Mud ☐ Sludge ☐ Debris ☐ Grease  
Silt Depth: (in.) Deposits Extent:  
Infiltration: **None** Pipe Seal Cond: **Sound**
